NSWC TR 83-366

# CONSTANT CURRENT DISCHARGE TESTS OF A 12 "D" CELL IN SERIES Li/SO<sub>2</sub> BATTERY PACK UNDER COUNTER ARM DECOY REQUIREMENTS

SEPTEMBER 1983

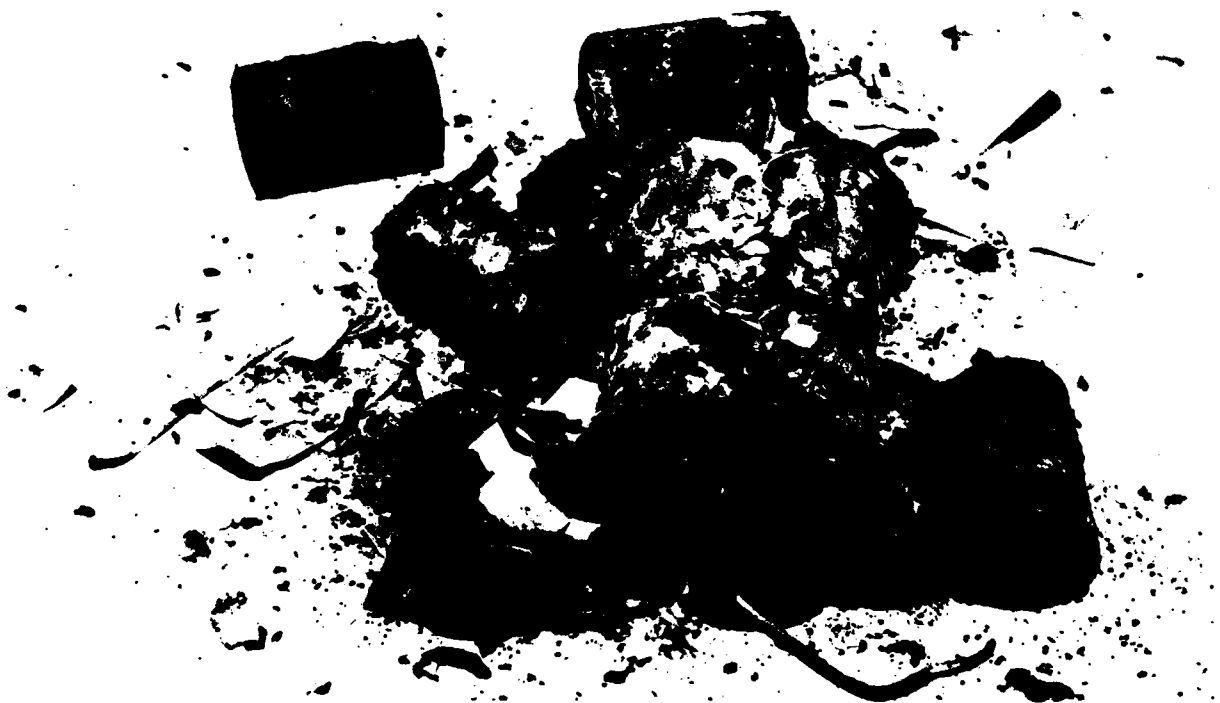
FIGURE 8. BATTERY PACK #2 AFTER CONSTANT CURRENT DISCHARGE (WITH HEAT TAPE REMOVED)

The second battery had an open circuit voltage of 36.08 volts and was discharged at 21 amperes. The power supply in the circuit was limited to 36 volts. The current remained constant at 21 amperes (+ 0.05A) until the battery went into reversal. When the discharge began, the voltage immediately dropped to 24.14 volts. It partially recovered, reaching a maximum of 26.44 volts at 3 minutes 8 seconds. The voltage then dropped slowly for 4 minutes then it began to drop quickly. At 8 minutes 46 seconds the battery went into voltage reversal. At 8 minutes 49 seconds into the test, a "pop" occurred, accompanied by smoke. Seven seconds later flames began at the bottom and top of the battery. At 9 minutes 3 seconds into the test, an explosion knocked the battery over onto its side. "Pops" occurred at 9 minutes 9 seconds and 9 minutes 17 seconds into the test. At 9 minutes 45 seconds, 10 minutes 6 seconds, and 10 minutes 55 seconds into the tests, failures occurred resulting in "torch-like" flames. The temperature history of the hottest thermocouple as well as the battery voltage is shown in Figure 6. The vent and flame response described here is similar to results which have been observed many times during similar tests. The battery pack was somewhat intact after the test; although it fell apart after the heat tape was removed. Figures 7 and 8 show the battery before and after the heat tape was removed.

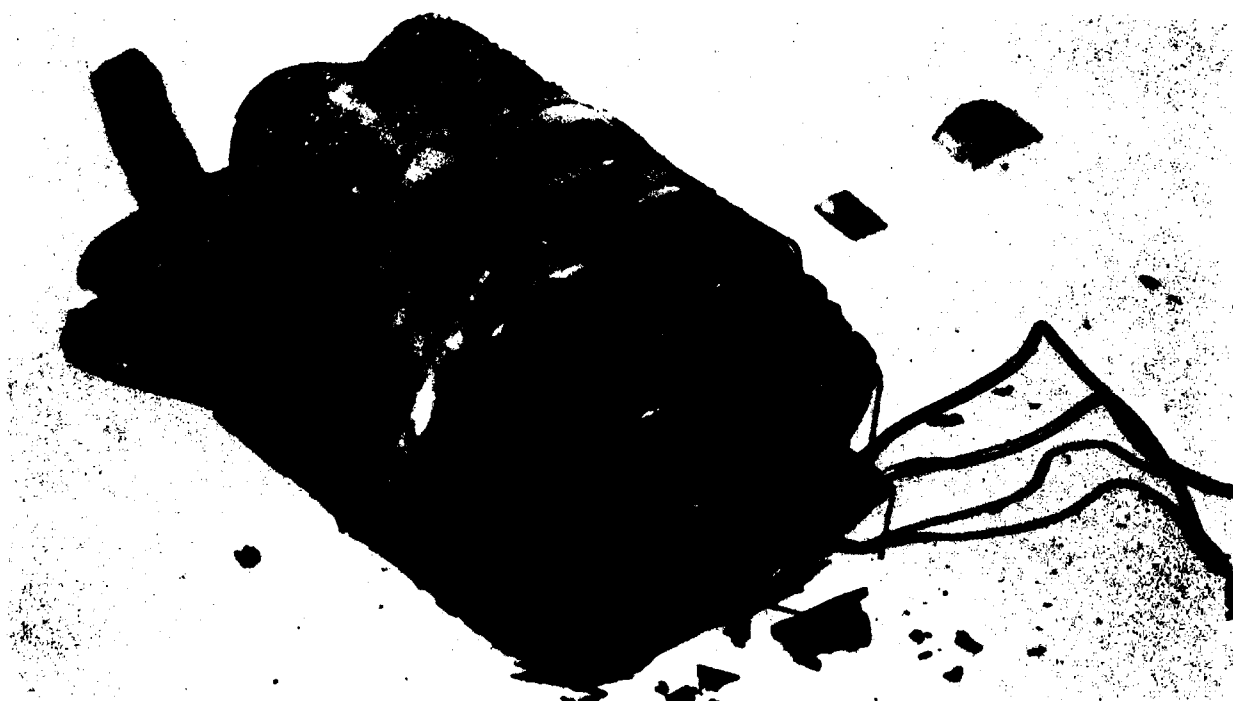
**FIGURE 10. BATTERY PACK #3 AFTER DISCHARGE AND INCINERATION (WITH HEAT TAPE REMOVED)**

The internal impedance of the third battery was too high to allow any appreciable current to be pushed through using the power supply after the switch was closed. The battery voltage dropped quickly to 24 volts, and then to 0. A short time after the start of the test (approximately 3 minutes), a local cell failure occurred with venting and flame. Flames lasted approximately 25 seconds and smoke about 1-1/2 minutes after the failure. No further events were observed for 8 minutes. The pack was then destroyed through incineration using heat tape with predictable results: venting and flame. Figure 9 shows the pack after incineration. The local failure can be seen as a hole burned through the heat tape. Figure 10 shows the pack with the heat tape removed.

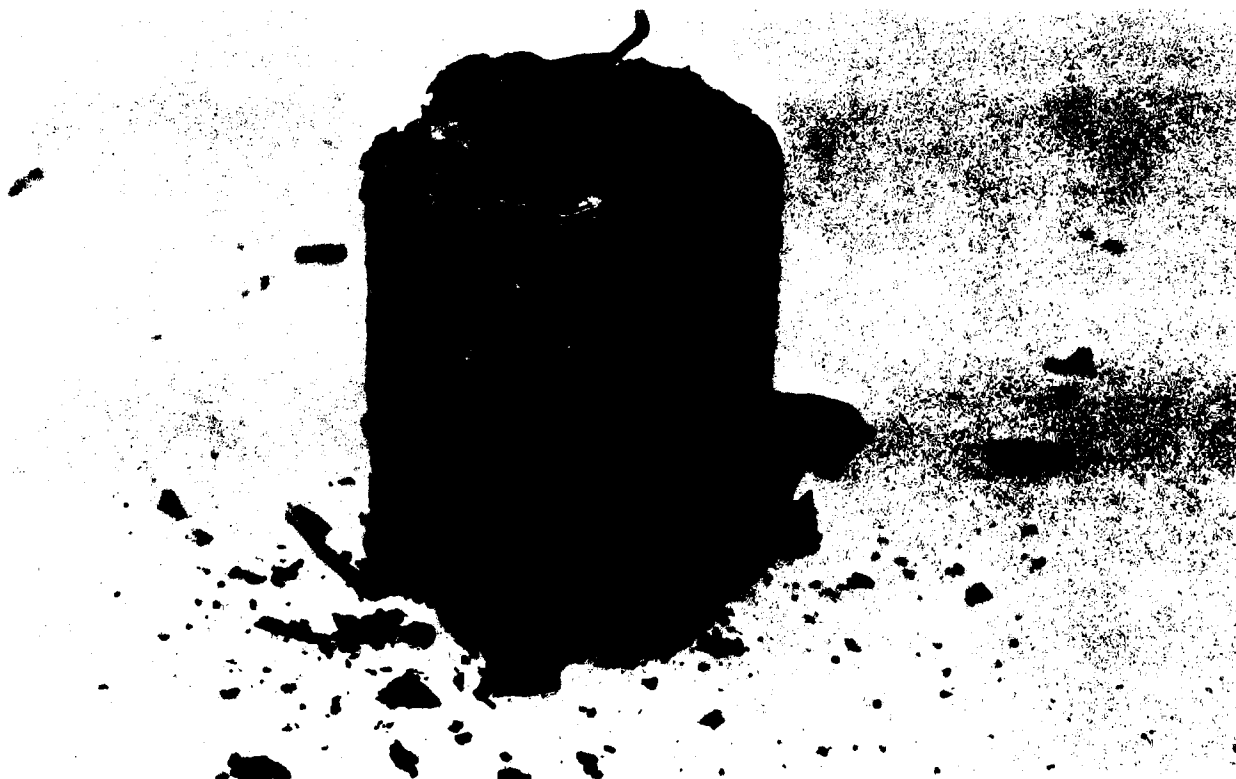
FIGURE 12. BATTERY PACK #4 AFTER INCINERATION (WITH HEAT TAPE REMOVED)

The fourth battery pack was found to be defective. Using a multimeter, the pack had an internal impedance of greater than 100 ohms. The 21 ampere current necessary could not be run through the battery using the power supply. The battery was placed directly across the 2-ohm load. The voltage dropped immediately to 0 volt indicating at least one bad cell in the battery. The battery was incinerated using heat tape. The incineration produced predictable results with smoke, flames, an occasional "pop" and Li scattering. Figures 11 and 12 show the pack before and after the heat tape was removed.
